DAMAGE IN HISTORIC RAMMED EARTH STRUCTURES: A CASE STUDY AT AMBEL, ZARAGOZA, SPAIN

Paul Jaquin* (United Kingdom)
Integral Engineering Design

Christopher Gerrard** (United Kingdom)
Department of Archaeology, University of Durham

Charles Augarde*** (United Kingdom)
School of Engineering and Computing Sciences, University of Durham

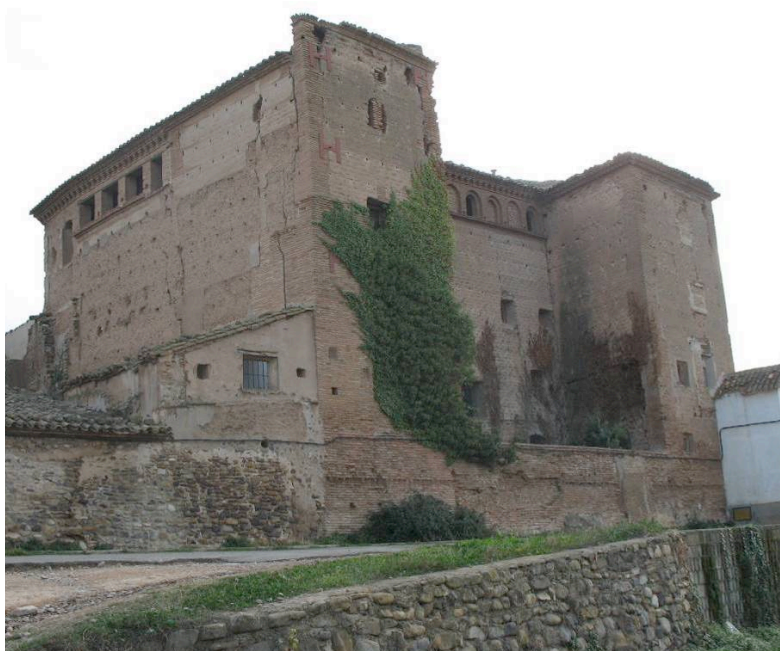
Today there are two independent sets of cracks in the east elevation (Fig. 1) – two slightly inclined cracks in the centre of the building; and two vertical cracks at the north end of the east elevation, which are related to the lean of the north gable end wall. This wall leans outwards from ground level to mid-height of the second storey, with the section above this being built vertically on top of a leaning wall. The current owners of the building installed crack monitoring points in the early 1990s and this monitoring shows the continued opening of the cracks at the northern end of the tower. As a result,

Fig. 1. The preceptory at Ambel, north-east elevation. The gallery of arches between the towers is typical of 16th century architecture in this region. The first phase precinct wall reaches the base of ivy and stands 3m high.

shows that there is no structural tie between the between the two. Any structural movement therefore results in an opening of the joint. This is particularly a problem in later medieval architecture, where brick quoins are used, and structural movement (for example of the gable end of a structure) is unrestrained and leads to an opening of the joint. An example of this can be seen on Fig. 1 immediately below the eaves at the northern end of the tower.

Where water has been allowed to gather and run down the face of a wall, cast structures, such as described in Section 4.1, are observed on the face of the wall (Fig. 5). However, these have served as a forewarning of further damage and caused the building owners to undertake repairs. As a result, there are no deep incisions into the rammed earth as shown in Fig. 4, and as observed at other historic rammed earth sites (Jaquin, 2008b). However, the eaves do not protrude on any of the faces, and this may have allowed a water flow down the face of the wall. If water is allowed to gather behind the render, then the rammed earth may become locally saturated, meaning the liquid bridges providing a bond between the render coat and the rammed earth may become saturated, causing the render to spall away from the wall (Fig. 1).

tie bars were placed at ceiling level at the ground, first and second storeys in 2000. These are fixed internally by bolting onto the ceiling beams and protrude externally to link to H-shaped bars on the facade which were positioned so as to overlap the brick quoins (Fig. 1).

may have succeeded in stiffening the north end of the structure, but because ground movement has not been halted, further deformation and cracking has occurred. In 2000 H-shaped spreader plates were fixed to the face of the wall, which are affixed to 150 mm x 80 mm I-beam sections running through the length of the building. These I-sections are bolted to the transverse ceiling timbers at each side of the building at ground, first and second floor levels.

Although this intervention follows sensible principles, it may be noted that the horizontal component of the lean of the gable wall is transferred directly to the transverse timbers through bolting, which maybe prove unsatisfactory, with the bolts shearing from the timber with increased horizontal load from the gable wall. Monitoring of crack growth shows that the placement of this system has not arrested the growth of the cracks, suggesting that it is yet to engage or is proving ineffective. Future work is now being suggested which will involve the placement of spreader plates on the outside of the south wall, allowing the I-beam sections to span the whole length of the building and thereby stiffen the whole structure.

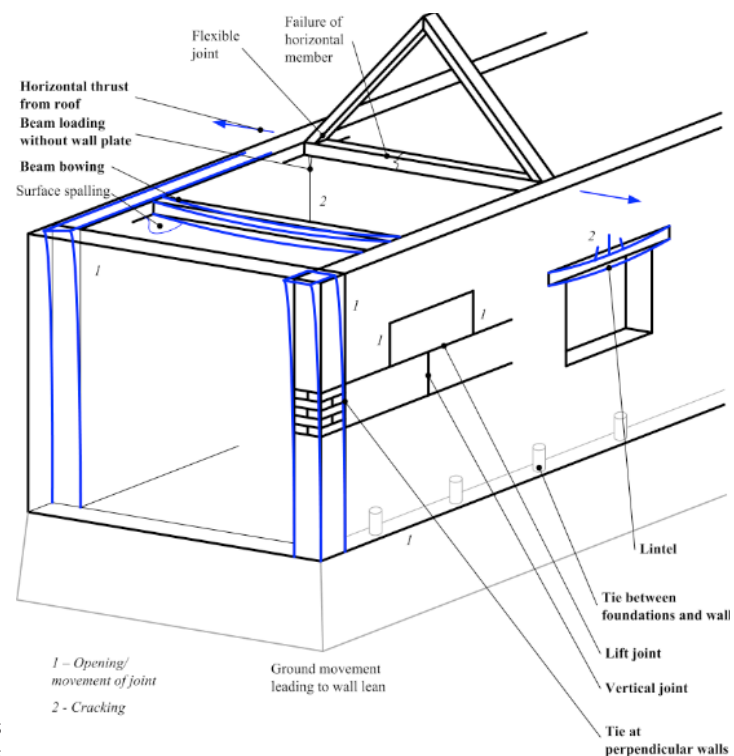
There are a wide range of causes of structural problems, including ground movement, failure or inadequacy of building elements, incorrect design, or excessive loading. This paper focuses on those issues which are felt to be specific to rammed earth. Fig. 2 shows some of the mechanisms which have been identified. Potential causes of structural problems are shown in bold, while their effects are shown in a normal font. The numbers 1 and 2 in italics refer to positions where opening or cracking may

Fig. 2. Examples of failures of structural elements

or later alteration to the structure, there is the potential for shear failure of the wall beneath the loaded beam. Out of plane failure can also occur where a beam joining a wall is insufficiently stiff and bows under loading. This causes an increased load at the face of the wall, and can lead to spalling of the material at the face (Fig. 2).

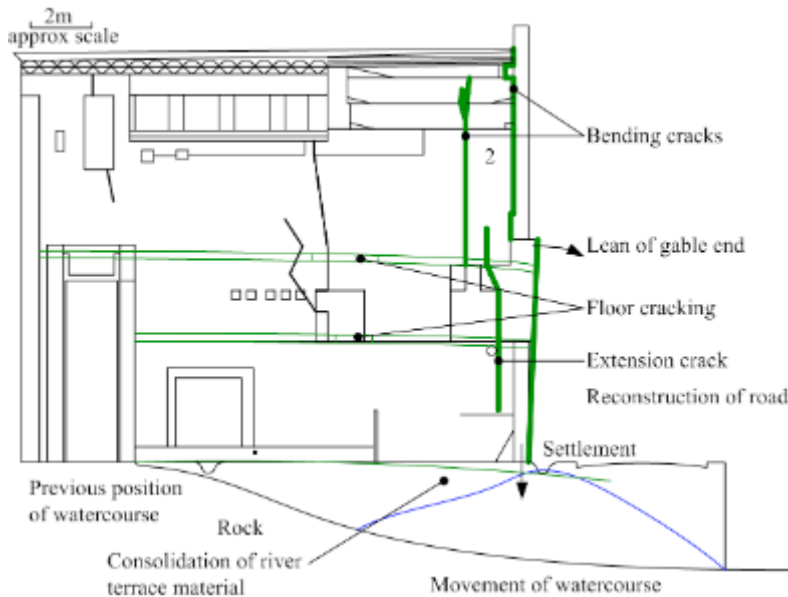
The gable end wall of the north-east granary at Ambel is showing a significant outward lean at the head of the wall, and monitoring of the cracking patterns shows that the cracks continue to open. The cause of this lean is assumed to be an ineffective retaining wall to the north of the gable wall, allowing continued settlement of the ground. The nature of the foundations of the tower is not known. As it is not currently possible to reinstate this wall, or to upgrade the road, hard intervention techniques have been used.

In the late 18th century a number of hard repair measures were already being enacted at to prevent collapse of the leaning north wall. There is no structural tie between the rammed earth north and east walls, and the brick quoin at the corners. As described above, a further storey tower may have existed at the north of the granary, and this tower may have provided a structural tie between the gable end and the transverse walls. Analysis of the architectural fabric suggests that timber buttressing was placed against the external wall, and repairs were carried out to the ceiling arches at each floor. In addition, battens were embedded at the north end of the east and west walls, spanning to the leaning north wall. Their effectiveness is questionable, as cracks are present in the wall at the south end of these timbers. This indicates that the timbers

gable end wall. This timber is causing in-plane cracking of the rammed earth wall because of the lack of a wall plate.

Fig. 3. Cracking patterns and causes, east-facing elevation of the north-east tower at Ambel

Where the cause of the structural problem has been mitigated, then a soft repair of filling of the cracks is recommended. This will not only improve the appearance of the building but also prevent water ingress. At Ambel, cracks in the centre of the long east wall are thought to have formed prior to the movement of the gable end, and have therefore been filled. The filler is brick, which would originally have matched the scored rendered original face of the rammed earth, although this is now removed. Filling with similar fallen material in rammed earth is problematic, though the column method is recommended by Pearson (1997) and other possibilities are suggested in Jaquin (2008a).

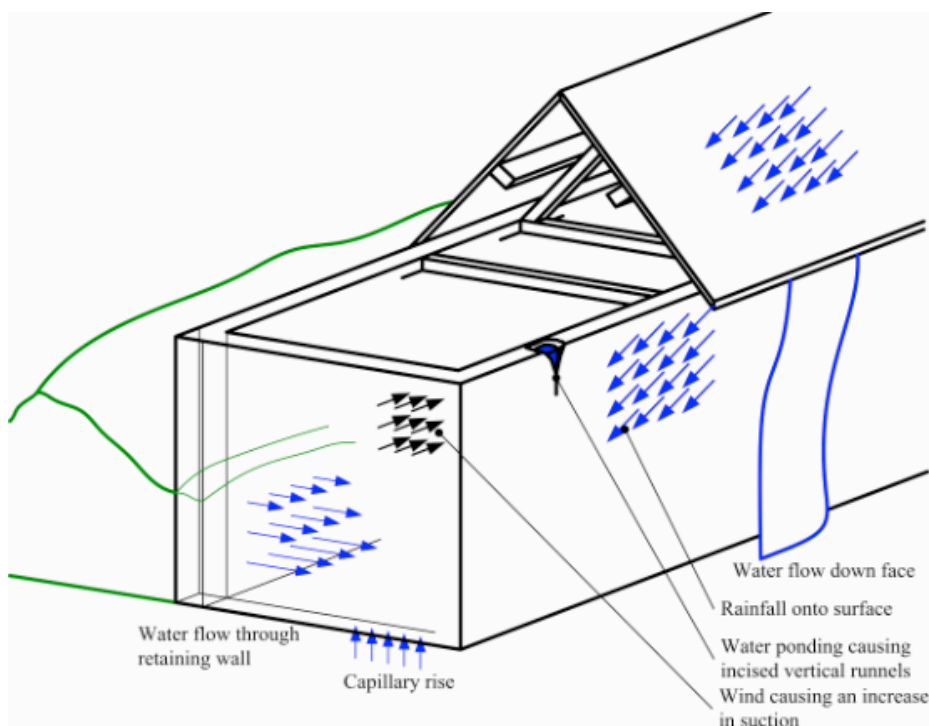
Fig. 4. Causes of damage by water

to flow down the surface of a wall. This usually happens where it is allowed to gather (pond) at the head of a wall, and flow down the face. Because of the larger volumes of water involved, the rate of water infiltration overtakes the rate at which water is removed from the wall by evaporation, and so a drip forms on the surface of the wall. This may allow the surface of the rammed earth to become saturated, and for soil particles to become suspended within the liquid and flow. This mechanism can be seen in the formation of worm cast type structures where material has first flowed into a slurry, then dried to leave mounds of fine material on the wall face. The presence of these structures indicates the downward movement of material and is thus indicative of past water flow. The likely cause of the formation of the structures is the slow downward movement of water down the face of a wall, for example a drip which is able to pick up material and transport it in solution down the wall, until such a point as the drip evaporates and the material is returned to the wall. Inspection of these structures indicates that they contain only very small particles, as it is only these which may be picked up by the water. The rate of infiltration of water into the body of the wall is sufficiently slow that the drip of water is able to continue down the face of the wall, saturating and therefore picking up smaller soil particles, before all the water is absorbed by capillary action into the wall and those smaller soil particles redeposited. If the rate of water flow is increased, such as by an ineffective drain, then larger soil particles and larger volumes of material are picked up by the water flow, and incisions form in the vertical face of the wall (Fig. 4). This mechanism involves the movement of material down the wall causes a

Repair of rammed earth walls damaged by water should only be attempted when the cause of the water flow has been addressed. It has been argued that the main repair strategy for water damage is reinstatement of the head of the wall to prevent further water flow down the face. This has taken the form of concrete ring beams for the restoration of the towers at Biar and La Rambla (Jaquin, 2008a) or as bamboo matting at Ait Ben Haddou in Morocco. If it is possible, then the roof of the structure must be reinstated, and the drainage from this correctly positioned.

Repair of the face of a wall, where damaged by water, should involve reinstatement with the fallen or similar material which will provide similar material properties (stiffness, permeability and shrinkage) as the rest of the wall. There are many examples of the repair of rammed earth buildings using a less permeable render such as cement (see Jaquin, 2008b). While this render reduces the flow of water into the wall, it also reduces the flow of water out of the wall. If water is able to enter the wall by any other means (for example through capillary rise), and is not able to escape (water only flows upwards by capillary rise), then there is an increase in water content of the wall. This leads to a loss of strength and stiffness, and the wall will fail, either through a the build up of water behind a less permeable render, or by becoming saturated and losing strength and stiffness.

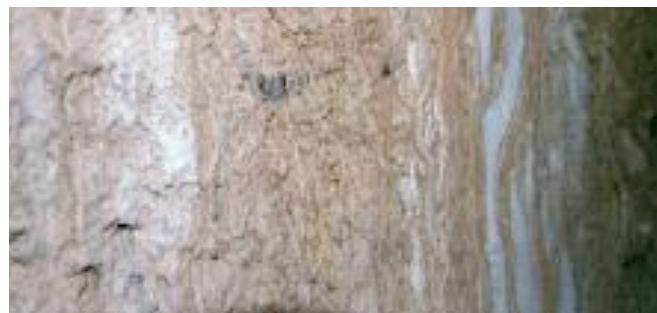
Fig. 5. Worm cast type structures visible at Ambel beneath a previously damaged roof section

significant neglect at periods through its history, and shows some evidence of water damage. The roof has now been repaired and seems to be effective, though some evidence of water damage remains.
