REVISTA DE GEOGRAFIA FÍSICA APLICADA  
NO ORDENAMENTO DO TERRITÓRIO E  
GESTÃO DE RISCOS NATURAIS

## Man's action and slope erosion. A case study in Tâmega Basin (1981) \*

António de Sousa Pedrosa\*\*  
Bernardo de Serpa Marques \*\*\*

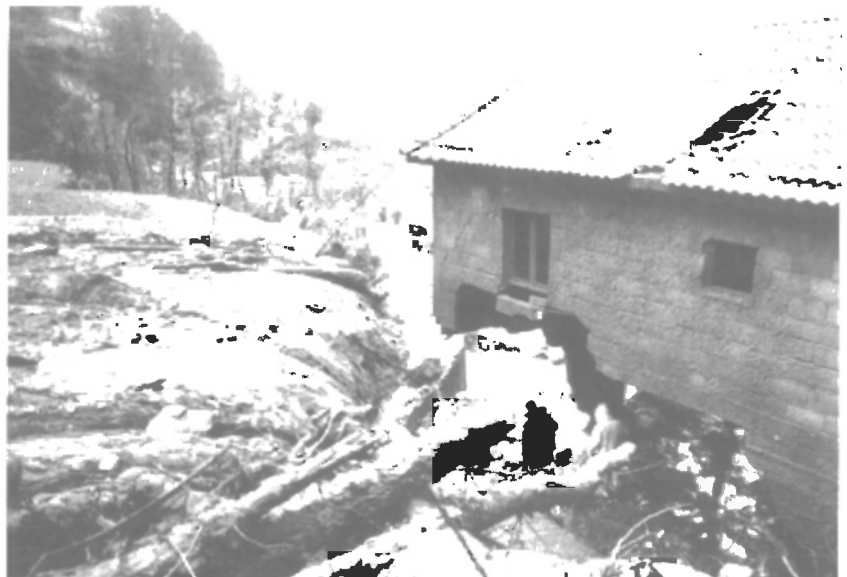
Fot. 1 - The building damaged by the landslide.

There was no way this enormous mass of mud and rocks could pass through the narrow channel that was the normal course the brook water took to flow under the 211 Road. When it overflowed, it found in its way a building made of stone and brick which had very unwisely been built directly on the talweg. It simply broke down the walls, left part of the upper floor without support and added to the moving mass, not only the building materials it had snatched away but also all the furniture and the people inside the building. It only stopped, as said before, when it reached the foot of the slope, i.e., in the bed of the river Tâmega.

the side of the road in a recess which had resulted from the correction of one of the many curves of the road; the builder had erroneously taken for granted that the drainage pipe under the road would defend it from the effects of the brook water.

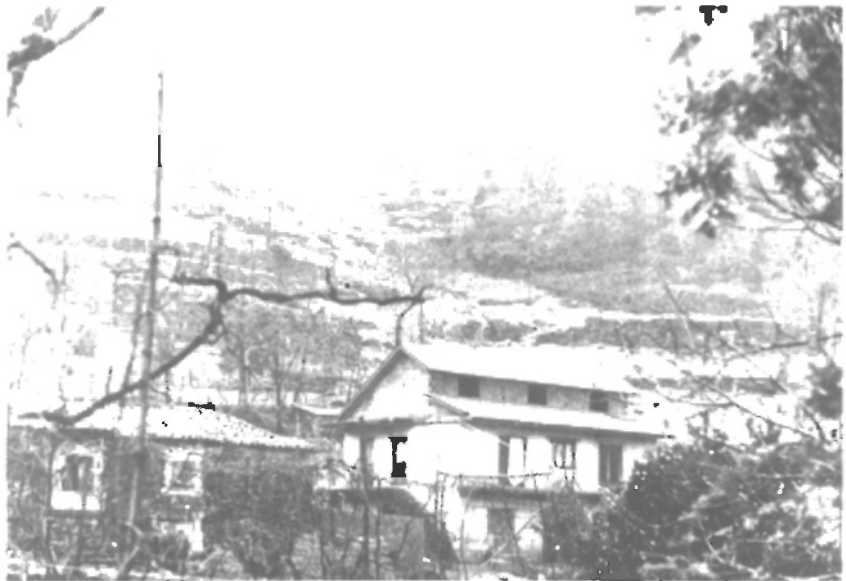
Fot. 2 - The small valley of the Arosa brook and the scar caused by the landslide.

and a maximum width of 17 meters. In all, the landslide affected an area of 828 square meters (Fot. 2). The scarp had a median height of 1.5 meters which allows us to estimate the total volume of the materials removed at about 1,240 cubic meters.

On the slope it left a longish scar in the direction of the maximum slope, with a length of 69 meters
